Chesapeake Boulevard (between East Little Creek Rd & Fishermans Rd) Pedestrian & Drainage Preliminary Engineering Report

City of Norfolk, Virginia

Department of Public Works

Timmons Group

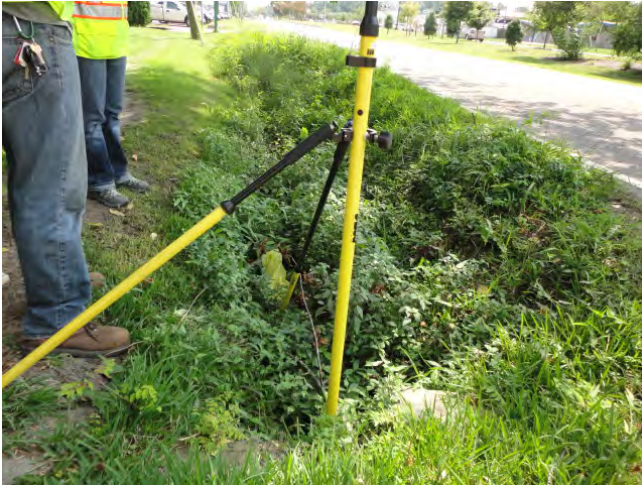
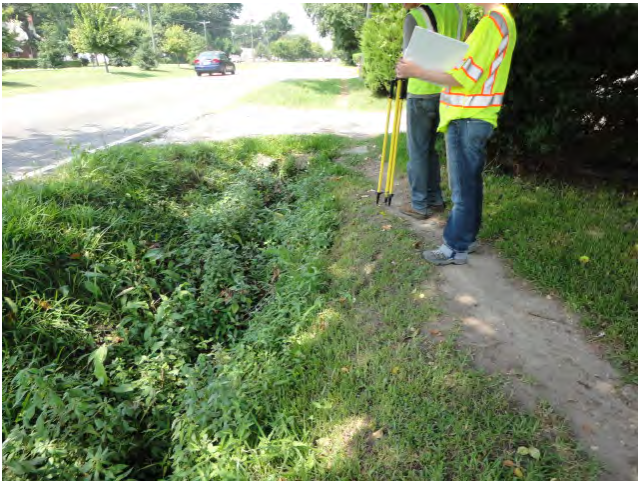
Structure Number **J07451**

Notes: pipe blocked by vegetation

Pipe Condition E(Poor , Fair , **G**ood , **A**waiting Install , **R**emoved from Service)

Ditch Condition	Bottom Width, ft	Top Width, ft	Depth, ft	Side Slopes (ft/ft)
G	2	4.5	2.1	0.6

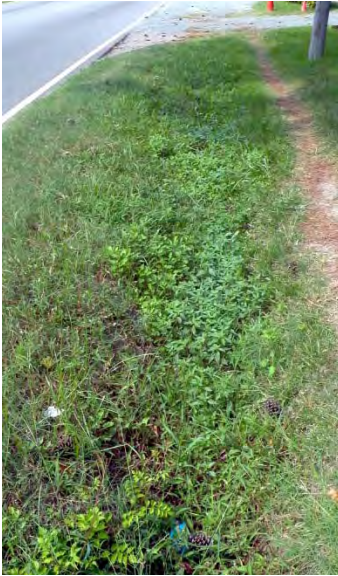
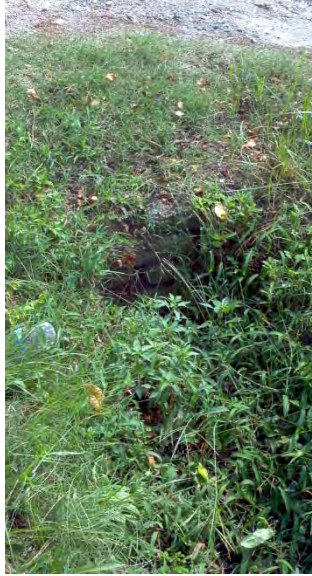
Structure Number **J07452**

Pipe Condition E(**P**oor , **F**air , **G**ood , **A**waiting Install , **R**emoved from Service)

Ditch Condition	Bottom Width, ft	Top Width, ft	Depth, ft	Side Slopes (ft/ft)
G	1.5	3	2.3	0.33

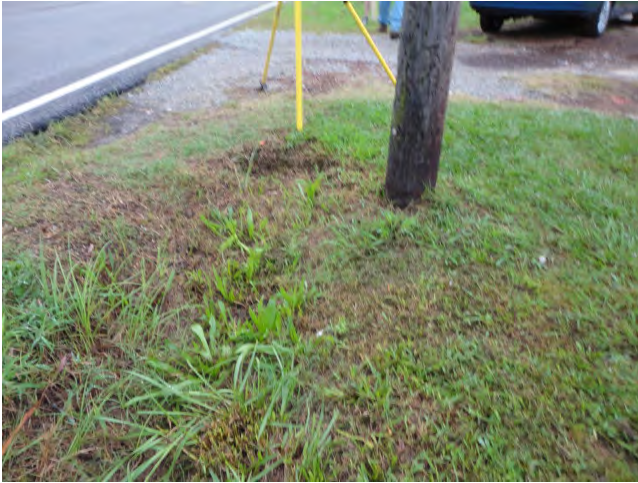
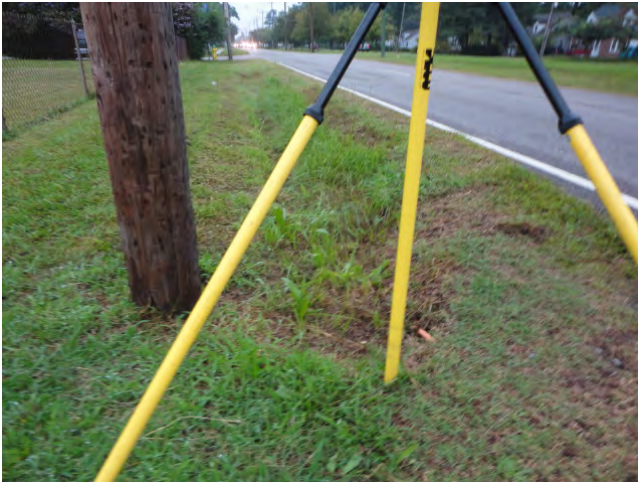
Structure Number **M8**

Notes: pipe squashed

Pipe Condition P (**P**oor , **F**air , **G**ood , **A**waiting Install , **R**emoved from Service)

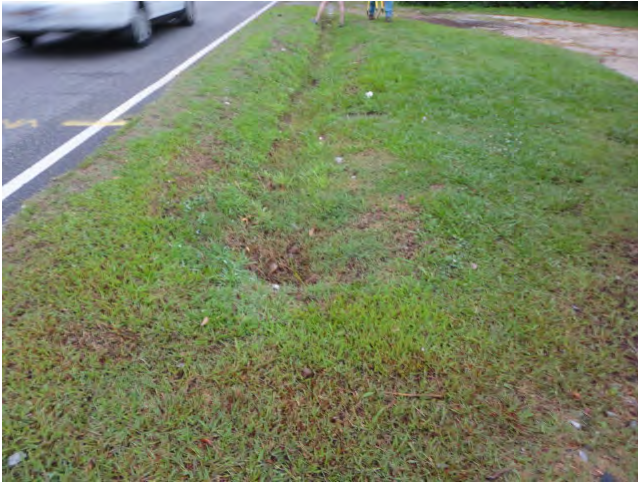
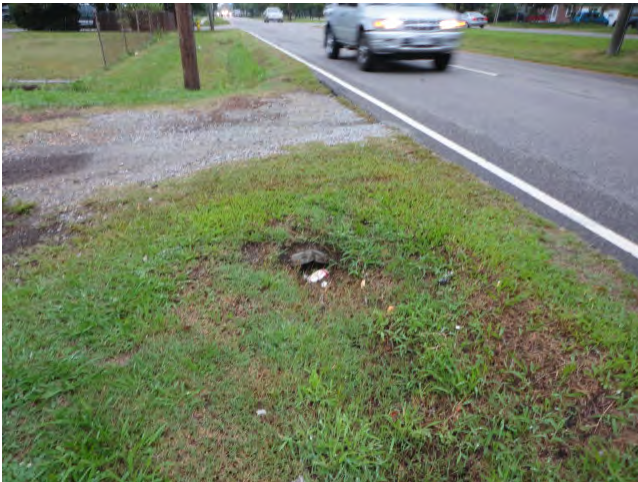
Structure Number M7

Notes: pipe squashed

Pipe Condition P (**P**oor , **F**air , **G**ood , **A**waiting Install , **R**emoved from Service)

Ditch Condition	Bottom Width, ft	Top Width, ft	Depth, ft	Side Slopes (ft/ft)
G	1	2.3	1	0.65

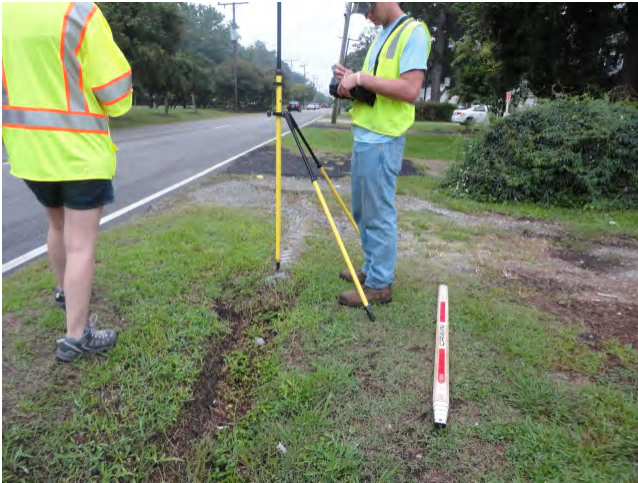
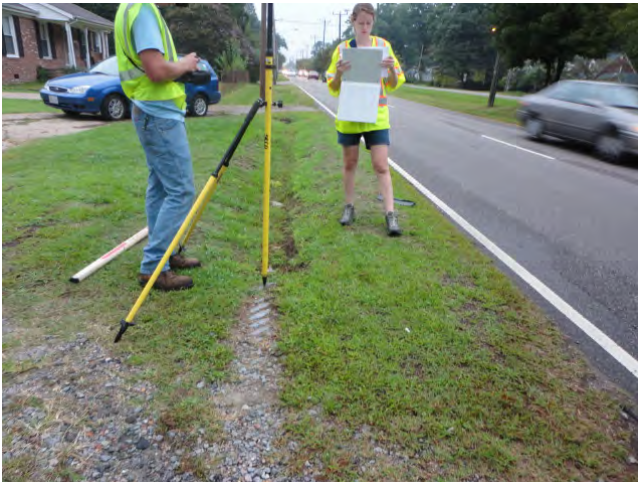
Structure Number **M6**

Pipe Condition P (**P**oor , **F**air , **G**ood , **A**waiting Install , **R**emoved from Service)

Ditch Condition	Bottom Width, ft	Top Width, ft	Depth, ft	Side Slopes (ft/ft)
G	0.67	2	1	0.65

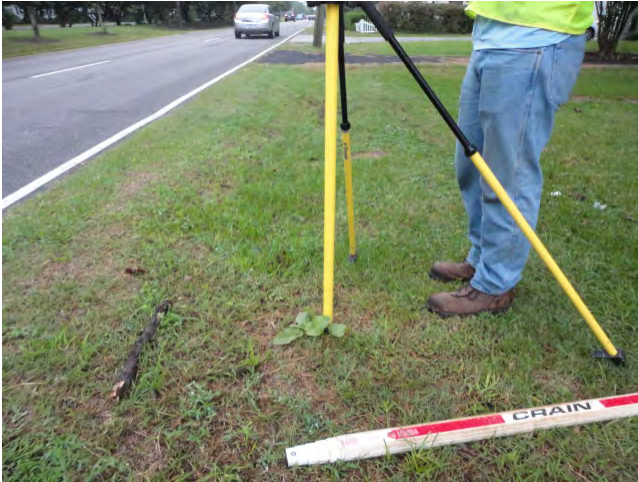
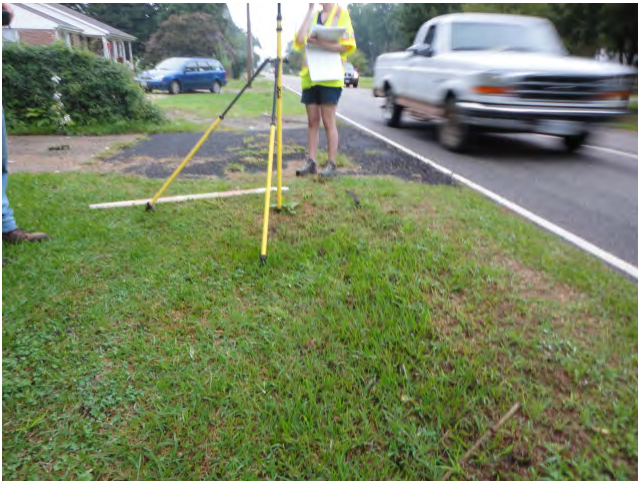
Structure Number M5

Notes: shallow swale; french drain PVC

Pipe Condition G (Poor , Fair , Good , Awaiting Install , Removed from Service)

Ditch Condition	Bottom Width, ft	Top Width, ft	Depth, ft	Side Slopes (ft/ft)
G

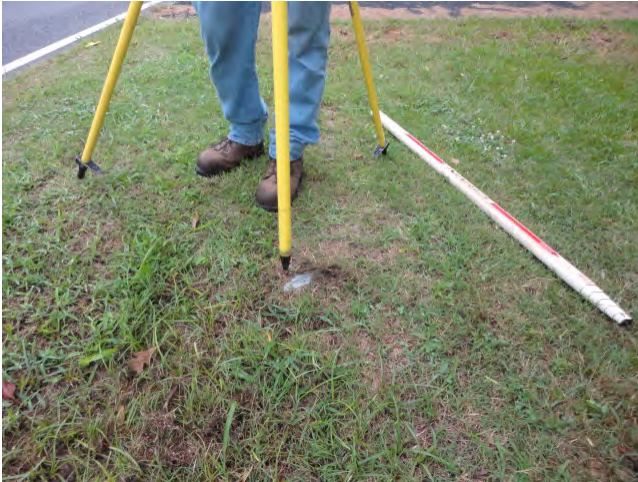
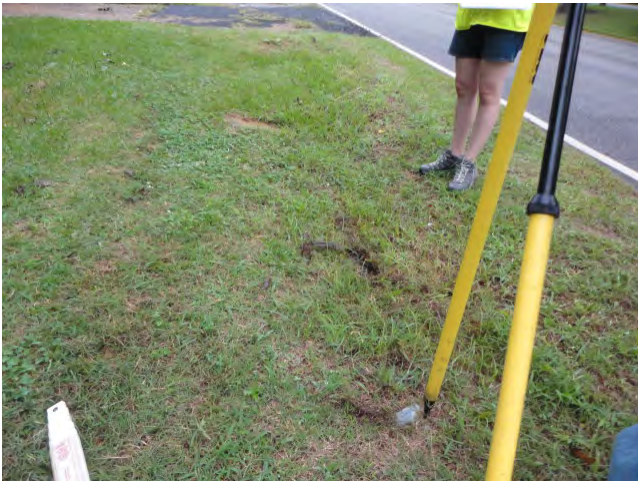
Structure Number **M4**

Pipe Condition P (**P**oor , **F**air , **G**ood , **A**waiting Install , **R**emoved from Service)

Ditch Condition	Bottom Width, ft	Top Width, ft	Depth, ft	Side Slopes (ft/ft)
NA

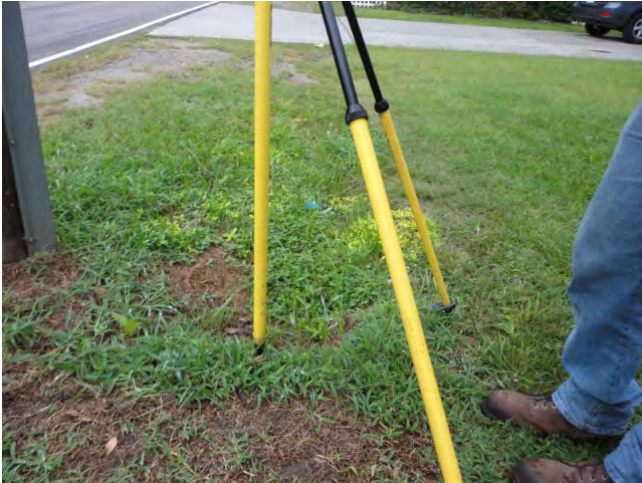
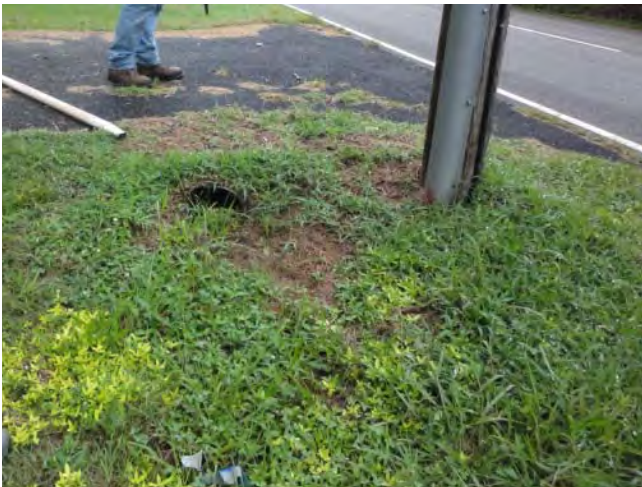
Structure Number **M3**

Pipe Condition P (**P**oor , **F**air , **G**ood , **A**waiting Install , **R**emoved from Service)

Ditch Condition	Bottom Width, ft	Top Width, ft	Depth, ft	Side Slopes (ft/ft)
G	1	2.5	0.5	1.5
